Government of Northwest Territories

NWT break up reports will be published routinely as break up unfolds. These reports will focus on regions with active snowmelt and ice break up. The geographic focus of the report will shift as conditions change. Additional information about basin conditions can be found in the ENR Snow Survey Bulletin and Spring Water Outlook, <u>available here</u>. If you have any photos or information about break up in your community, feel free to reach out to us: nwtwaters@gov.nt.ca.

Hay River:

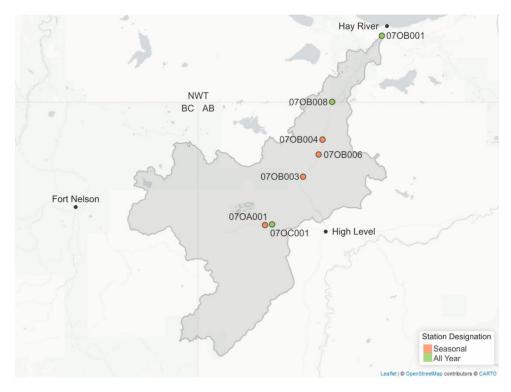
Above – Map of hydrometric stations in the Hay River basin. The station numbers are referenced in the water level plots below.

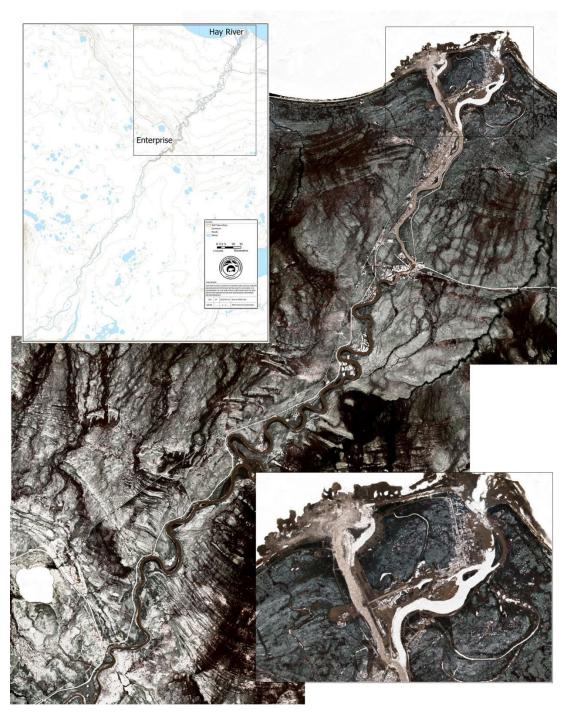
Above – Sentinel-2 satellite imagery taken on May 12th for the Hay River, between the town of Hay River and K'atl'odeeche First Nation, and Enterprise.

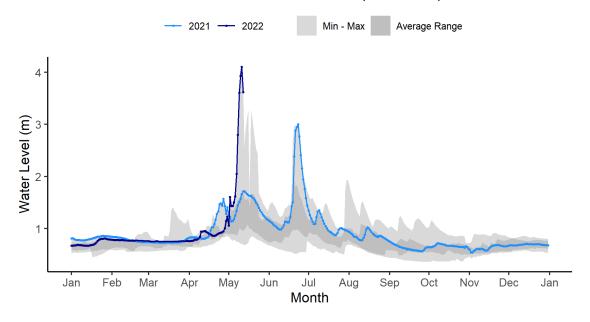
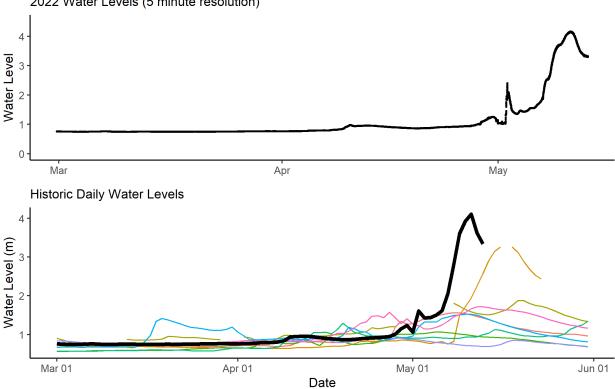
CHINCHAGA RIVER NEAR HIGH LEVEL (07OC001)

Above – Water level data at the Chinchaga River near High Level, AB. This plot shows high resolution (5 minute) water level data in the middle, and daily average data on the bottom. Water levels are now receding from their peak.

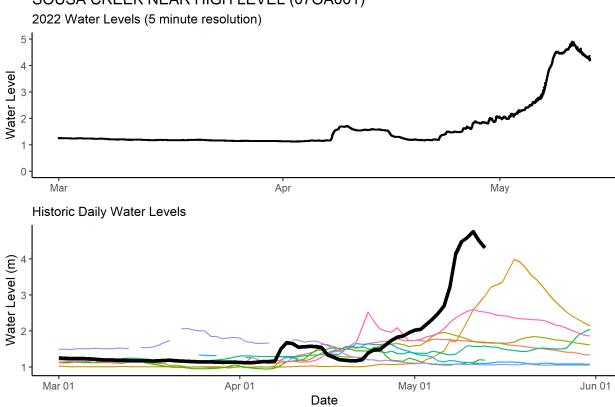
SOUSA CREEK NEAR HIGH LEVEL (07OA001)

Above - Water level data on Sousa Creek near High Level, AB. The Sousa River is a small tributary to the Hay River. Water levels are now receding from their peak.

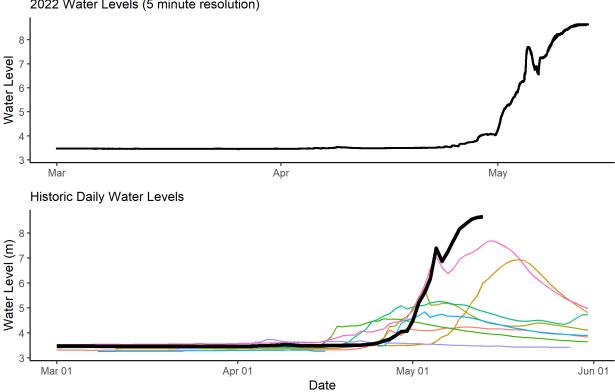
STEEN RIVER NEAR STEEN RIVER (070B004)

Above – Water level data on the Steen River near Steen River, AB. The Steen River is a tributary to the Hay River. Water levels are now levelling off as snowmelt water moves through the basin.

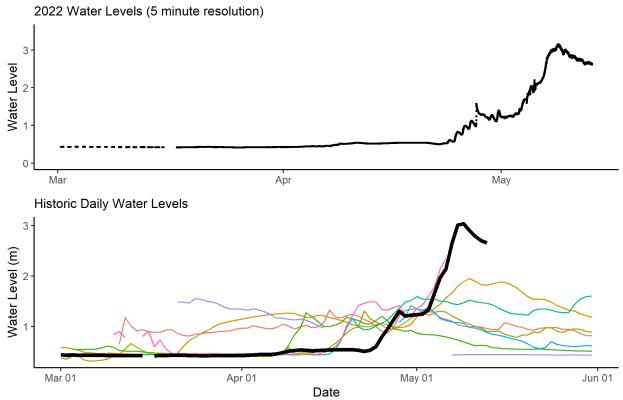
LUTOSE CREEK NEAR STEEN RIVER (07OB006)

Above – Water level data on Lutose Creek near Steen River, AB. Lutose Creek is a small tributary to the Hay River. Water levels are now receding from their peak.

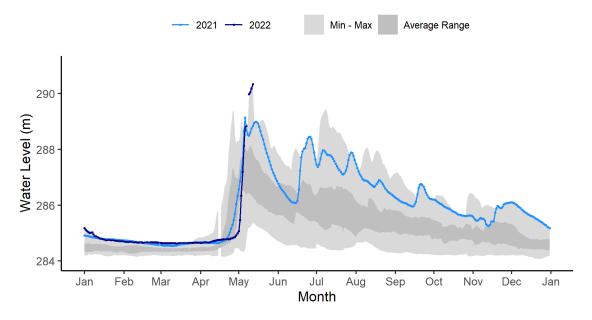
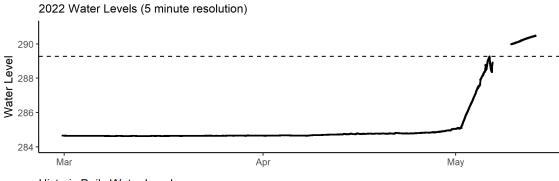
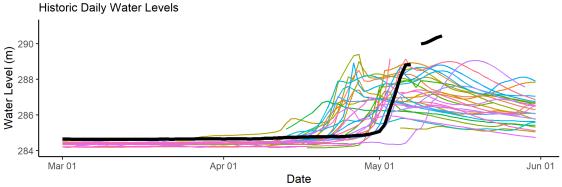
HAY RIVER NEAR ALTA/NWT BOUNDARY (070B008)

Above - The middle graph in this figure presents real time water level data at 5-minute resolution with the dashed line representing the peak water level from last year (2021). The lower graph shows daily average levels relative to the previous 20 years. Water levels continue to slowly rise as snowmelt water moves through the basin.

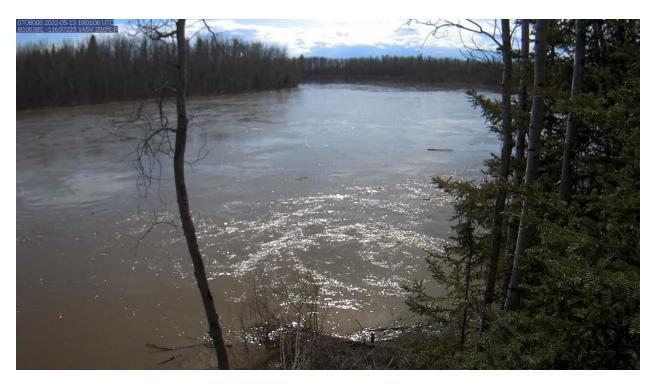
Above – Hay River near the border hydrometric gauge photo on May 13 at 13:00. Photo courtesy of Water Survey of Canada and GNWT.

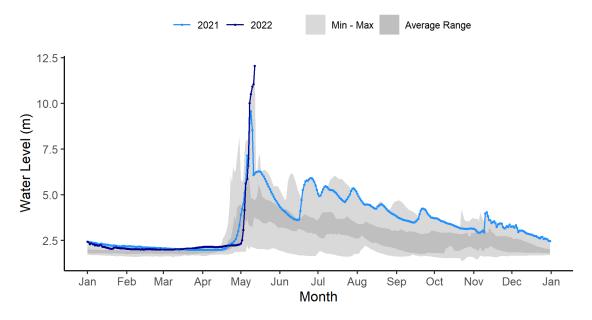
HAY RIVER NEAR HAY RIVER (070B001)

- Provisional water levels at the Hay River near Hay River gauge (just upstream of town) reached a maximum yesterday morning;
 - o The **provisional** maximum water level of 12.854 m was recorded at 06:50

- o The previous maximum water level at the gauge was 10.538 m in 1989
 - This does not include the 1963 flood (gauge was installed in the summer of 1963);

- According to provisional data, water levels at the gauge site have dropped almost
 5 m since the peak yesterday morning of 11:00 today;
- Upstream water levels on the main stem of the Hay River (NT-AB border and Meander River) are continuing to rise as snowmelt water moves through the basin;

Above – hydrograph of daily average levels for the previous two years.

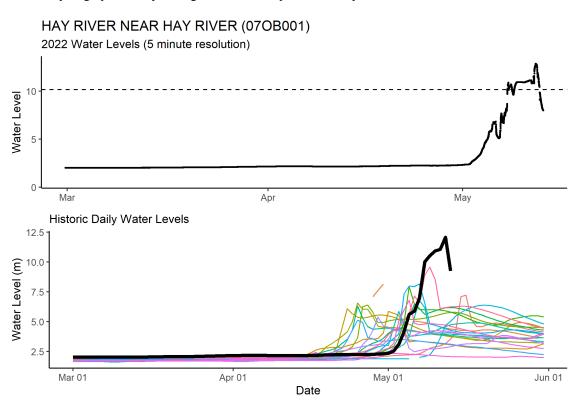
Above - The upper graph in this figure presents real time water level data at 5-minute resolution with the dashed line representing the peak water level from last year (2021). The lower graph shows daily average levels relative to the previous 20 years.

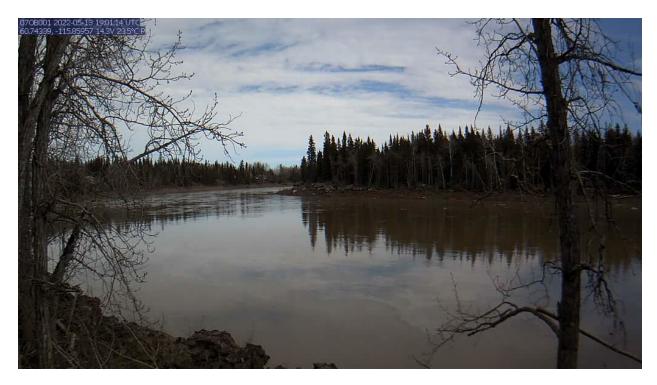
Above – Hay River near the Town of Hay River hydrometric gauge photo on May 13 at 13:00. Photo courtesy of Water Survey of Canada and GNWT.

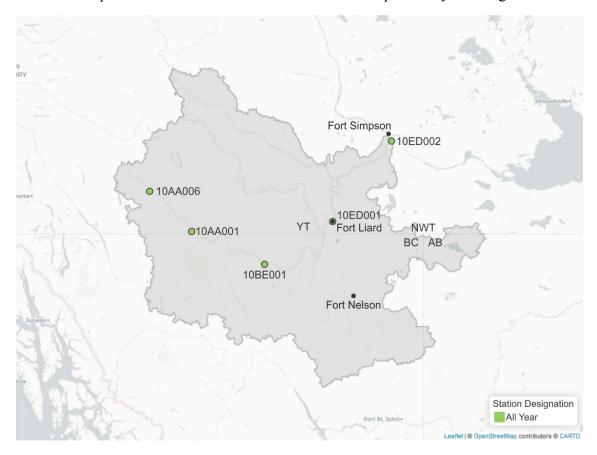
Above – Map of hydrometric stations in the Liard River basin. The station numbers are referenced in the water level plots below.

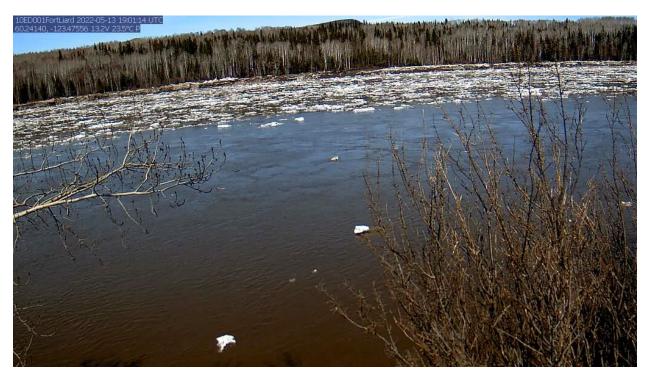
Liard River at Fort Liard [10ED001]: **Note:** The gauge is not currently producing data. The last available data were recorded on **May** 08 at 04:25.

Above – Liard River at Fort Liard hydrometric gauge photo from May 13 at 13:00. Photo courtesy of Water Survey of Canada and GNWT.

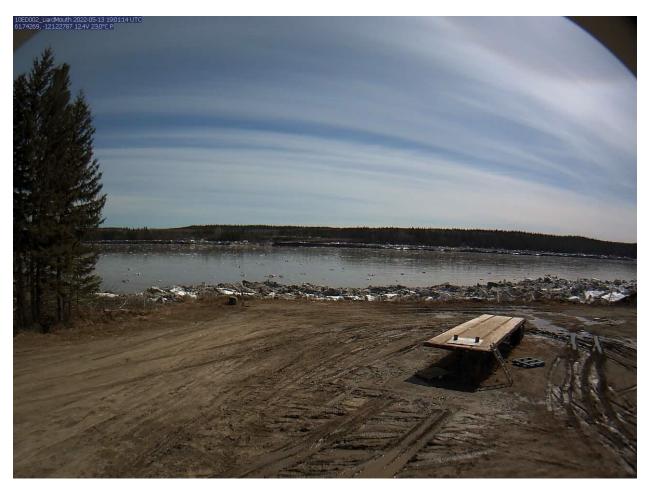
Note: The gauge is not currently producing data. Water Survey of Canada of Canada staff visited the gauge on May 07 at 10:20 and measured an instantaneous water level of 4.55 m and on May 09 at 10:15 and measured an instantaneous water level of 9.16 m.

Above – Liard River near the mouth hydrometric gauge photo from May 13 at 13:00. Photo courtesy of Water Survey of Canada and GNWT.

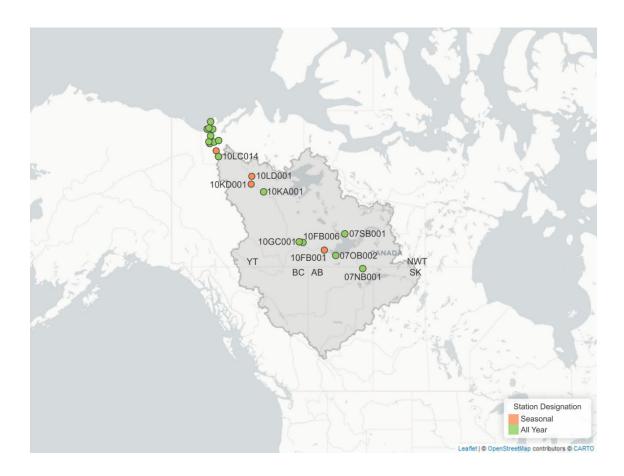
Above – Map of hydrometric stations in the Dehcho (Mackenzie River) basin. The station numbers are referenced in the water level plots below.

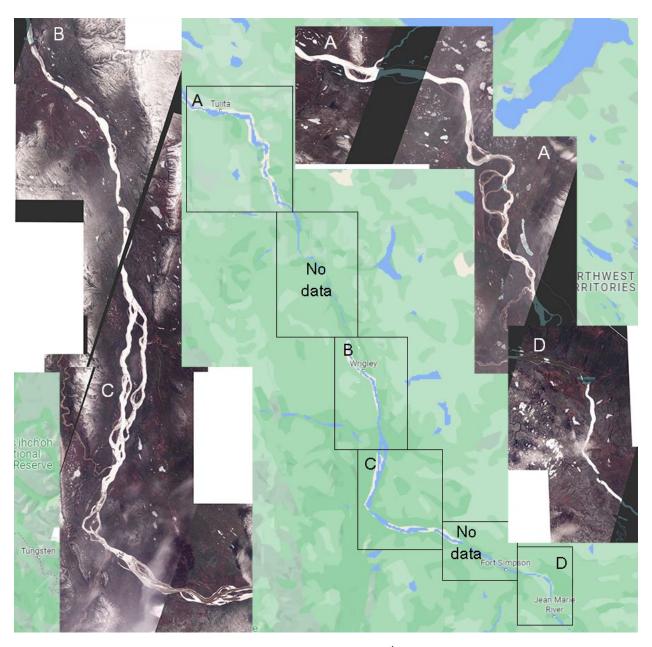
Above – Optical imagery taken between 12:30-13:00 MDT on May 12th for stretches of the Mackenzie River from Tulita to Jean Marie River. Obtained from Planet Explorer.

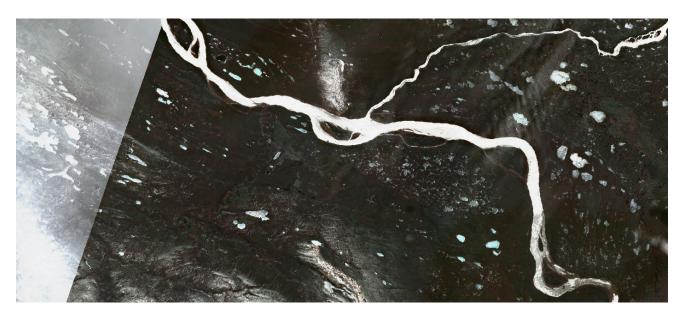
Above – Sentinel-2 satellite imagery taken on May 12th over Tulita.

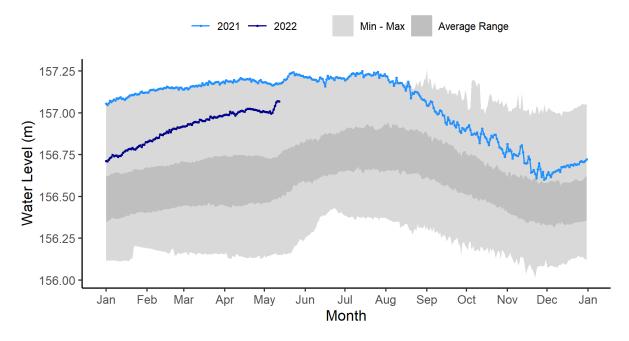
GREAT SLAVE LAKE AT YELLOWKNIFE BAY (07SB001)

Above – Water levels on Great Slave Lake at Yellowknife Bay for the previous two years. Although water levels have receded since the highs of 2020 and 2021, levels remain much higher than normal.

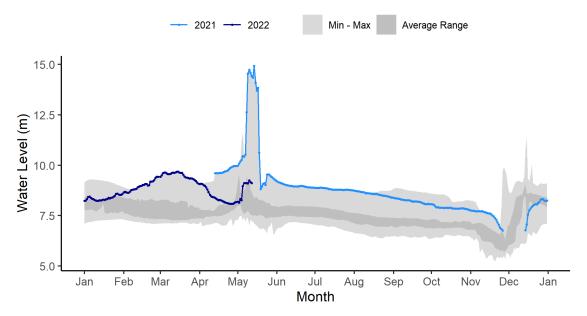
MACKENZIE RIVER AT STRONG POINT (10FB006)

Above – hydrograph of daily average levels for the previous two years. Note that the most recent point on this graph shows the daily average level from May 12 (yesterday).

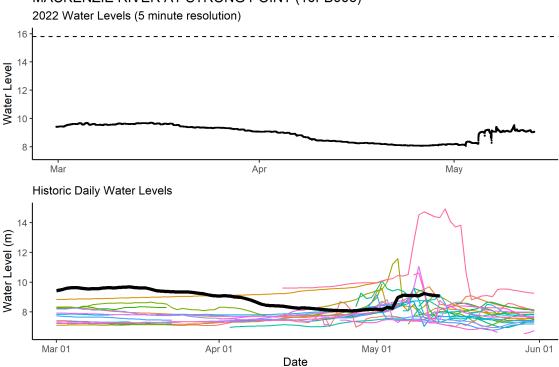
MACKENZIE RIVER AT STRONG POINT (10FB006)

Above - The upper graph in the figure presents real time water level data at 5-minute resolution with the dashed line representing the peak water level from last year (2021). The lower graph shows daily average levels relative to the previous 20 years.

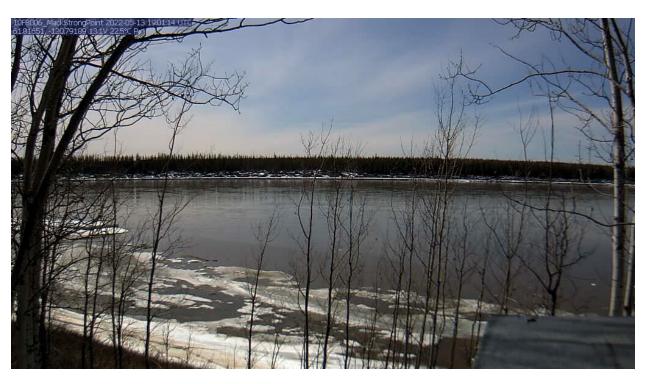
Above – Dehcho (Mackenzie River) at Strong Point hydrometric gauge photo from May 13 at 13:00. Photo courtesy of Water Survey of Canada and GNWT.

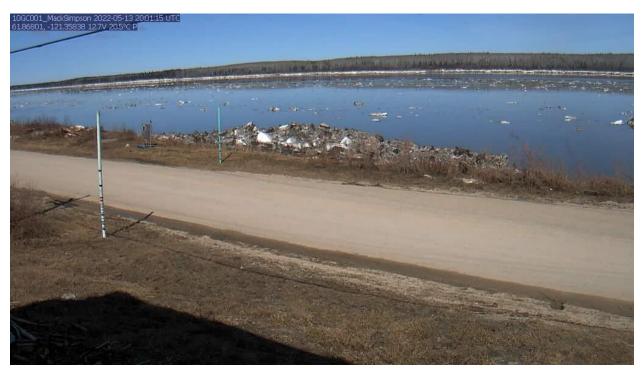
Note: The sensor is not currently producing data. The river is open at Fort Simpson and small amounts of ice are moving well.

Above – Dehcho (Mackenzie River) at Fort Simpson hydrometric gauge photo from May 13 at 14:00. Photo courtesy of Water Survey of Canada and GNWT.

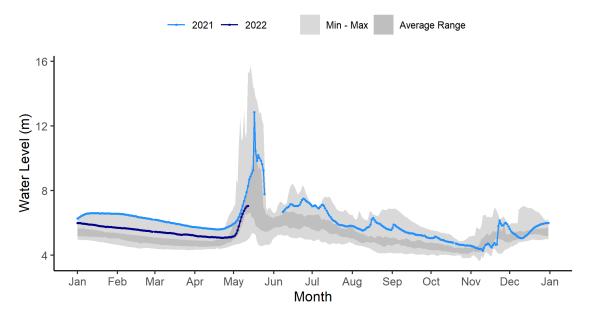
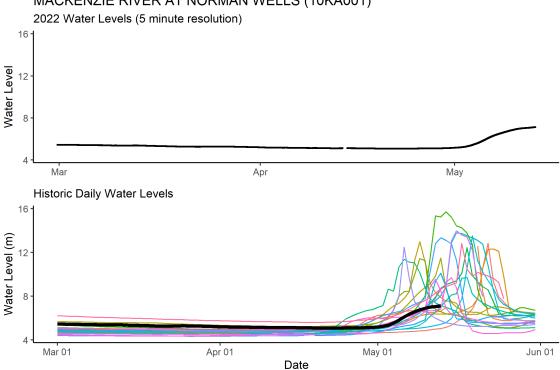
MACKENZIE RIVER AT NORMAN WELLS (10KA001)

Above – The middle graph in the figure presents real time water level data at 5-minute resolution while the lower graph shows daily average levels relative to the previous 20 years. Water levels on the Mackenzie River at Norman Wells have begun to rise, with the timing being approximately average to previous years.

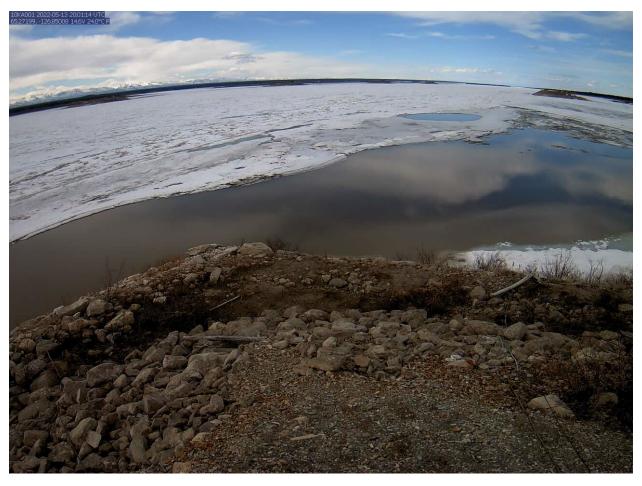
Above – Mackenzie River at Norman Wells hydrometric gauge photo from May 13 at 14:00. Photo courtesy of Water Survey of Canada and GNWT.

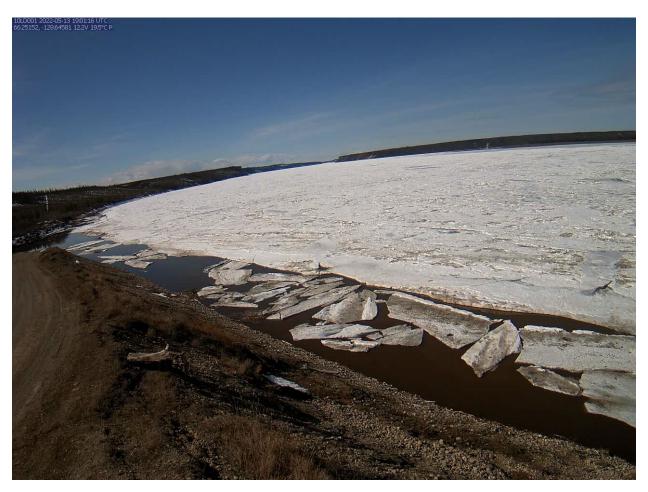
Above – Mackenzie River at Fort Good Hope hydrometric gauge photo from May 13 at 13:00. Photo courtesy of Water Survey of Canada and GNWT.

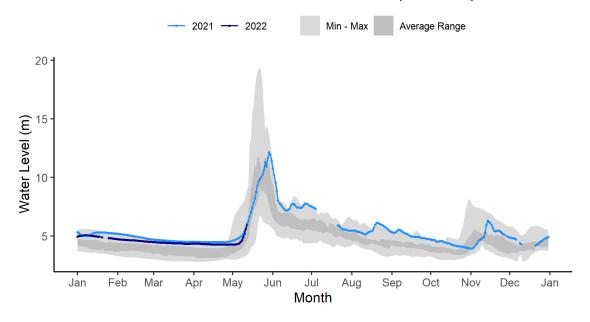
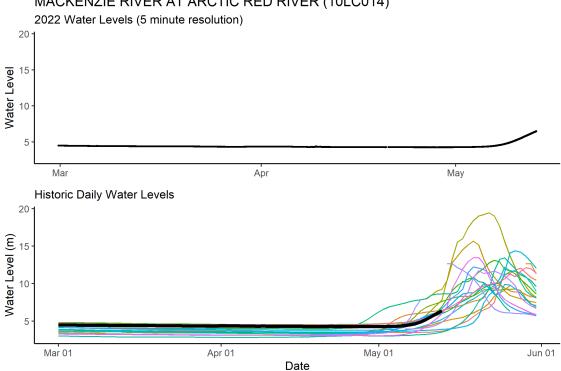
MACKENZIE RIVER AT ARCTIC RED RIVER (10LC014)

Above - The middle graph in the figure presents real time water level data at 5-minute resolution while the lower graph shows daily average levels relative to the previous 20 years. Water levels on the Mackenzie River at Arctic Red River have slowly begun to rise, with the timing being approximately average to previous years.

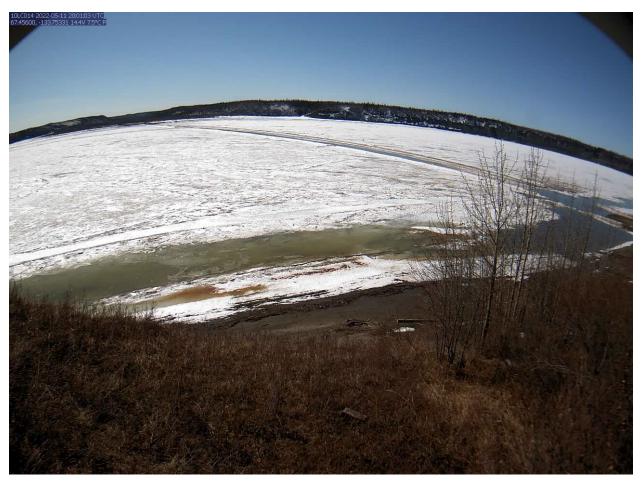
Above – Mackenzie River at Arctic Red River hydrometric gauge photo from May 11 at 13:00 (last available image). Photo courtesy of Water Survey of Canada and GNWT.

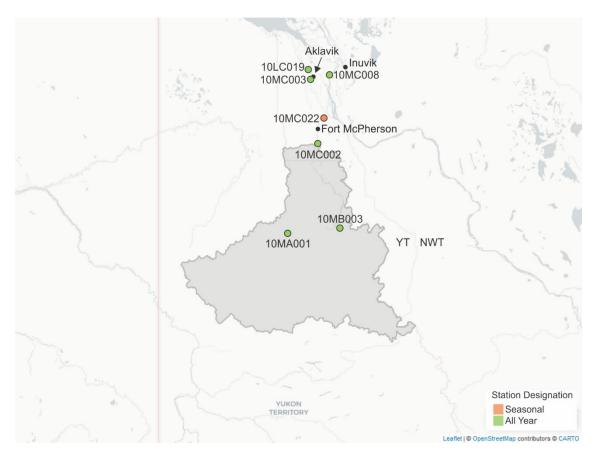
Above – Map of select hydrometric stations in the Peel River basin and the Beaufort Delta. The station numbers are referenced in the water level plots below.

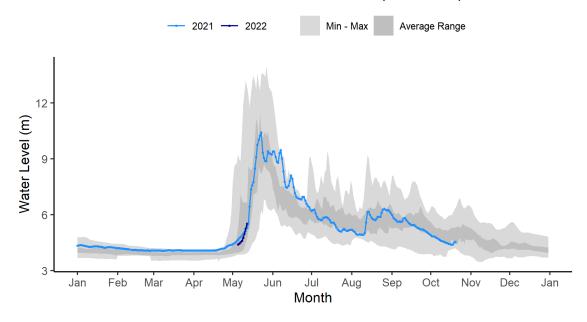
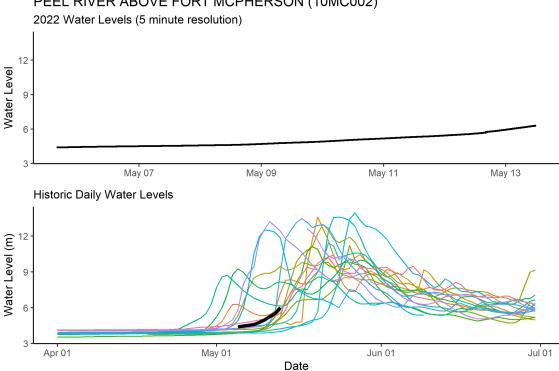
PEEL RIVER ABOVE FORT MCPHERSON (10MC002)

Above - The middle graph in the figure presents real time water level data at 5-minute resolution while the lower graph shows daily average levels relative to the previous 20 years. Water levels on the Peel River at Fort McPherson have slowly begun to rise, with the timing being approximately average to previous years.

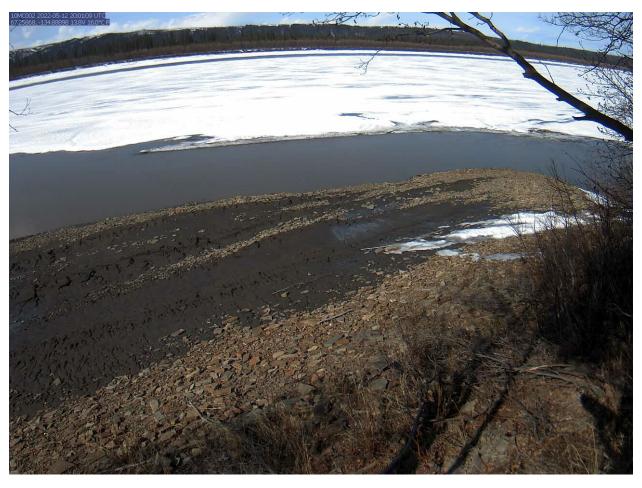
Above – Peel River at Fort McPherson hydrometric gauge photo from May 12 at 14:00. Photo courtesy of Water Survey of Canada and GNWT.

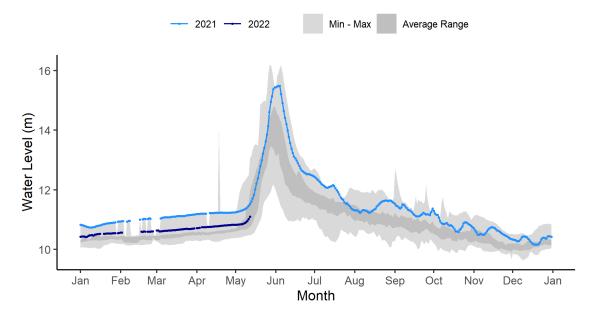
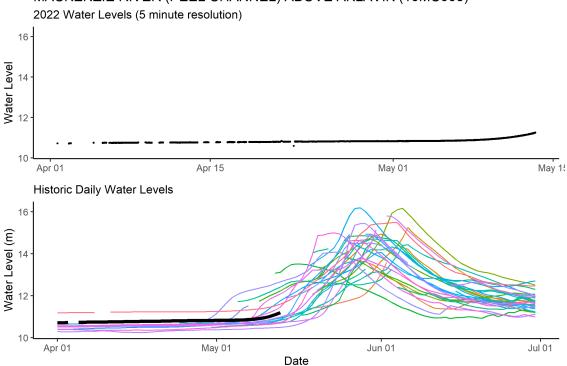
MACKENZIE RIVER (PEEL CHANNEL) ABOVE AKLAVIK (10MC003)

Above – The middle graph in the figure presents real time water level data at 5-minute resolution while the lower graph shows daily average levels relative to the previous 20 years. Water levels in the Mackenzie Delta are slowly beginning to rise. Water levels are lower than last year but have been higher than average throughout the winter.

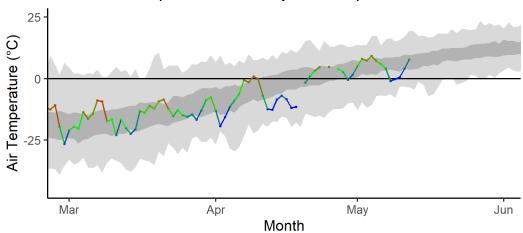
2022 Fort Simpson Mean Daily Air Temperatures

Weather information informs how snow and ice will melt and provides information about how this spring is unfolding relative to previous springs. Locations included here cover basin areas that feed into NWT rivers that are currently undergoing break up. The first set of plots show how temperatures have been relative to average (dark grey band) this spring, while the second set is Environment and Climate Change Canada (ECCC) weather forecast data for the next seven days.
