Government of Northwest Territories

# Hay River Morning Update – May 12, 2022: 09:00

This is a morning update on the status of water levels on the Hay River and its tributaries produced by the Environment and Natural Resources hydrology group.

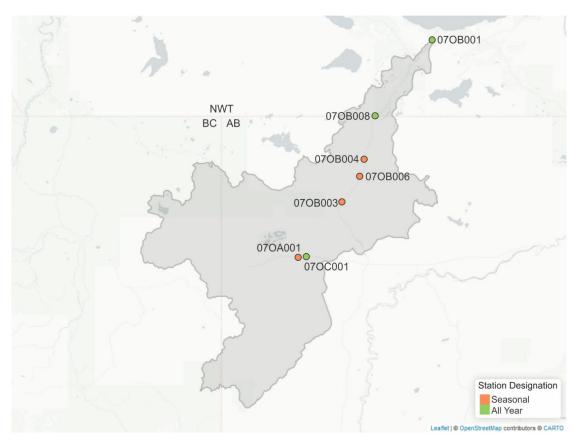
*Above* – Map of hydrometric stations in the Hay River basin. The station numbers are referenced in the water level plots below.

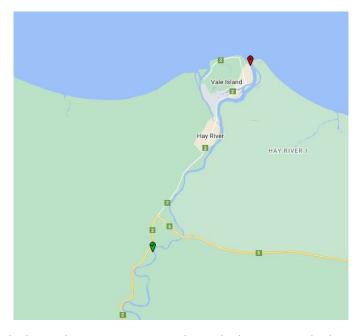
Above – Map of the two hydrometric gauges near Hay River. The lower green dot is "Hay River near Hay River [07OB001]" the upper red dot (gauge is currently not transmitting data) is "Great Slave Lake at Hay River [07OB002]".

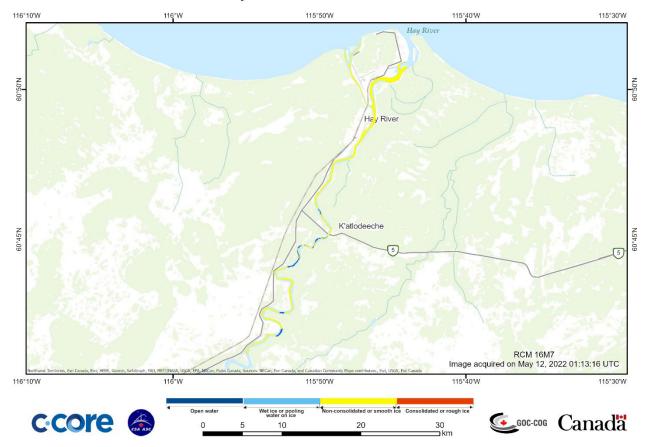
## Hay River Ice Classification

*Above* – Map of classified river ice in Hay River as of May 11 at 19:00. The yellow sections denote ice and the blue sections denote open water.

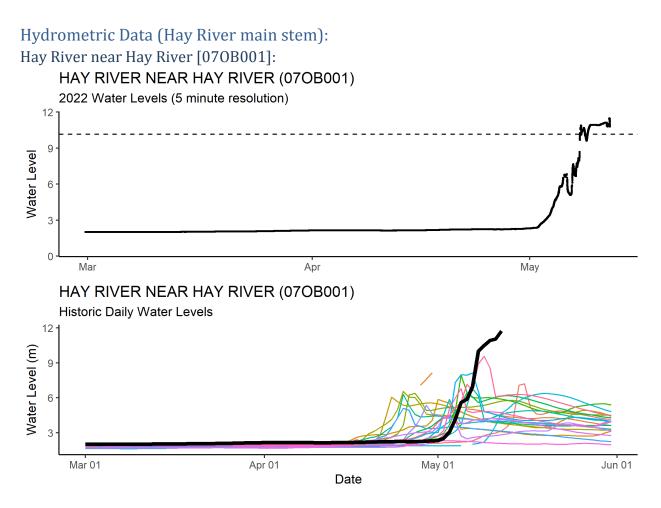
Above - The upper graph in this figure presents real time provisional water level data at 5-minute resolution with the dashed line representing the peak water level from last year (2021). The lower graph shows daily average levels relative to the previous 20 years. Water levels are severely impacted by ice and subject to major fluctuations.

- Provisional water levels at the Hay River near Hay River gauge have increased approximately 1.7 m over the past three days.
  - Prior to this, water levels had remained steady for approximately three days as ice held in the river channel due to cool temperatures;

- Ice began to shift yesterday with an ice jam from upstream moving into the downstream ice jam near town. This shift in ice caused water levels to increase rapidly through the Town of Hay River and K'atl'odeeche First Nation;

- Water levels are extremely volatile right now and impacted by ice in the channel. Rapid changes in water levels are possible;
- The upstream gauges on the main stem of the Hay River continue to slowly increase as snowmelt water moves through the system;

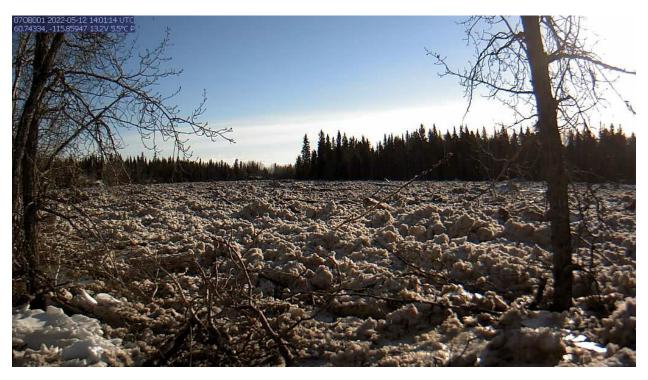
*Above* – Hay River near the Town of Hay River hydrometric gauge photo on May 12 at 08:00. Photo courtesy of Water Survey of Canada and GNWT.

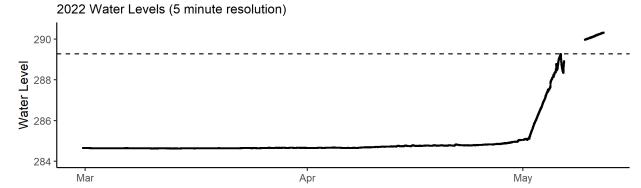
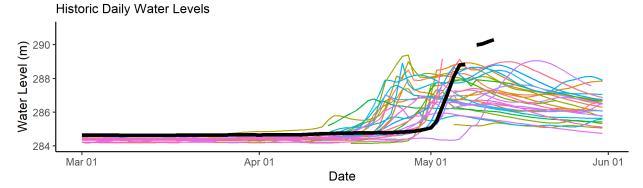
### HAY RIVER NEAR ALTA/NWT BOUNDARY (07OB008)

Above - The upper graph in this figure presents provisional real time water level data at 5-minute resolution with the dashed line representing the peak water level from last year (2021). The lower graph shows daily average levels relative to the previous 20 years. Water levels are slowly rising at this location.

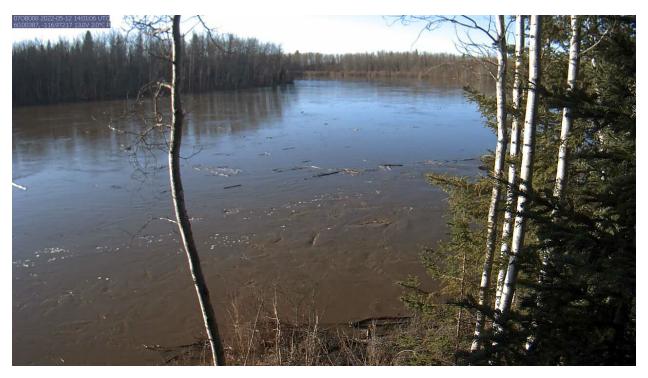
*Above* – Hay River near the border hydrometric gauge photo on May 12 at 08:00. Photo courtesy of Water Survey of Canada and GNWT.

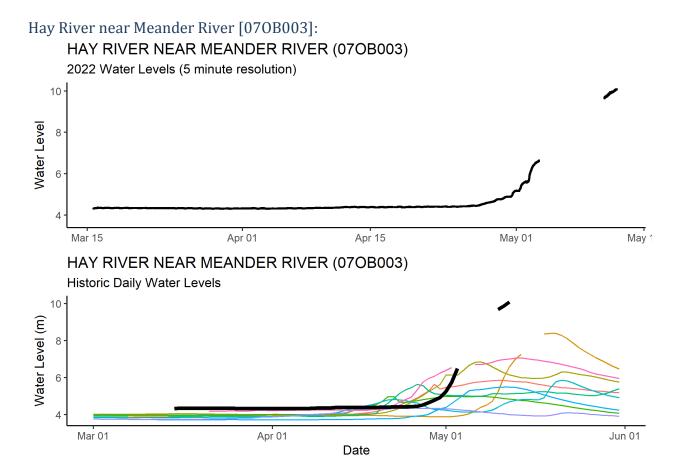
Above – Water level data at the Hay River near Meander River, AB. This plot shows high resolution (5 minute) water level data in the middle, and daily average data on the bottom. Water levels are slowly rising at this location.

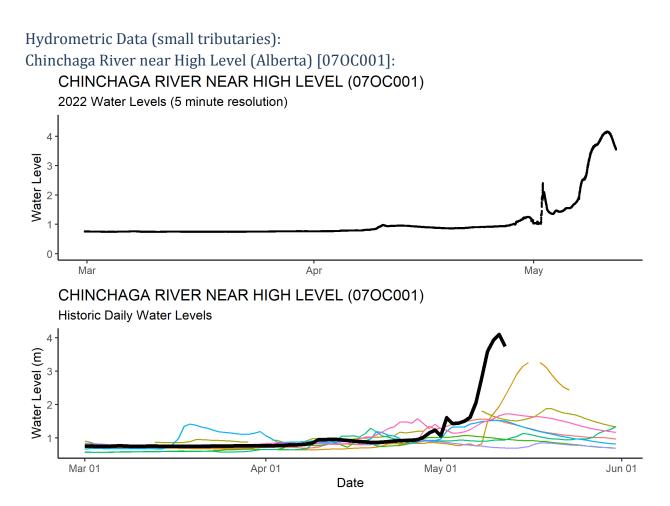
Above – Water level data at the Chinchaga River near High Level, AB. This plot shows high resolution (5 minute) water level data in the middle, and daily average data on the bottom. **Water levels are slowly receding at this location.**

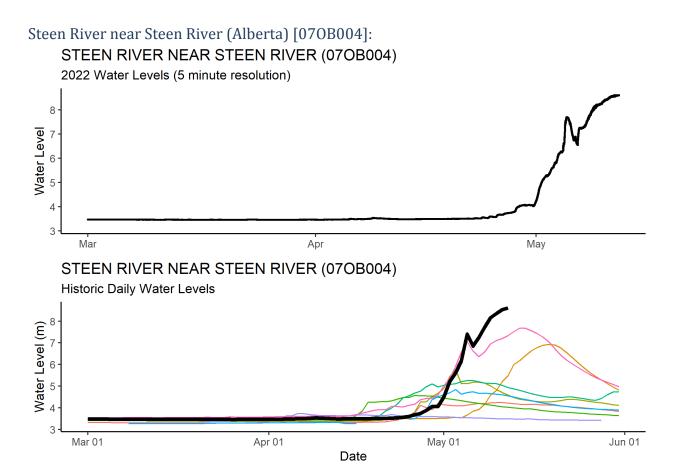
Above – Water level data on the Steen River near Steen River, AB. The Steen River is a tributary to the Hay River. Water levels are slowly rising at this location.

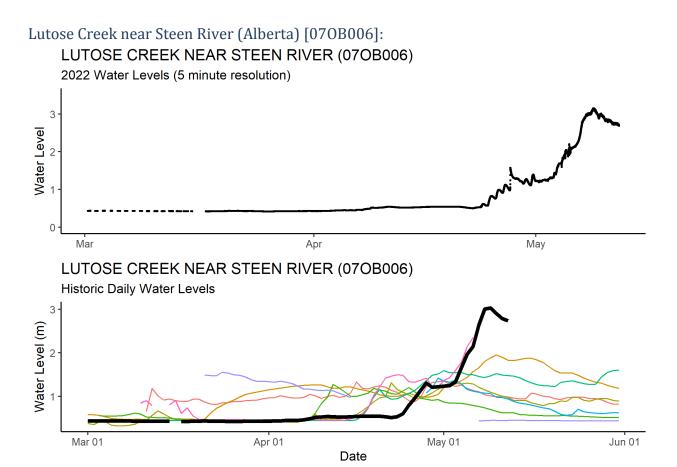
Above – Water level data on Lutose Creek near Steen River, AB. Lutose Creek is a small tributary to the Hay River. Water levels have risen 0.9 m over the course of the storm. Water levels are slowly receding at this location.
