NWT Water Monitoring Bulletin

– May 12, 2022

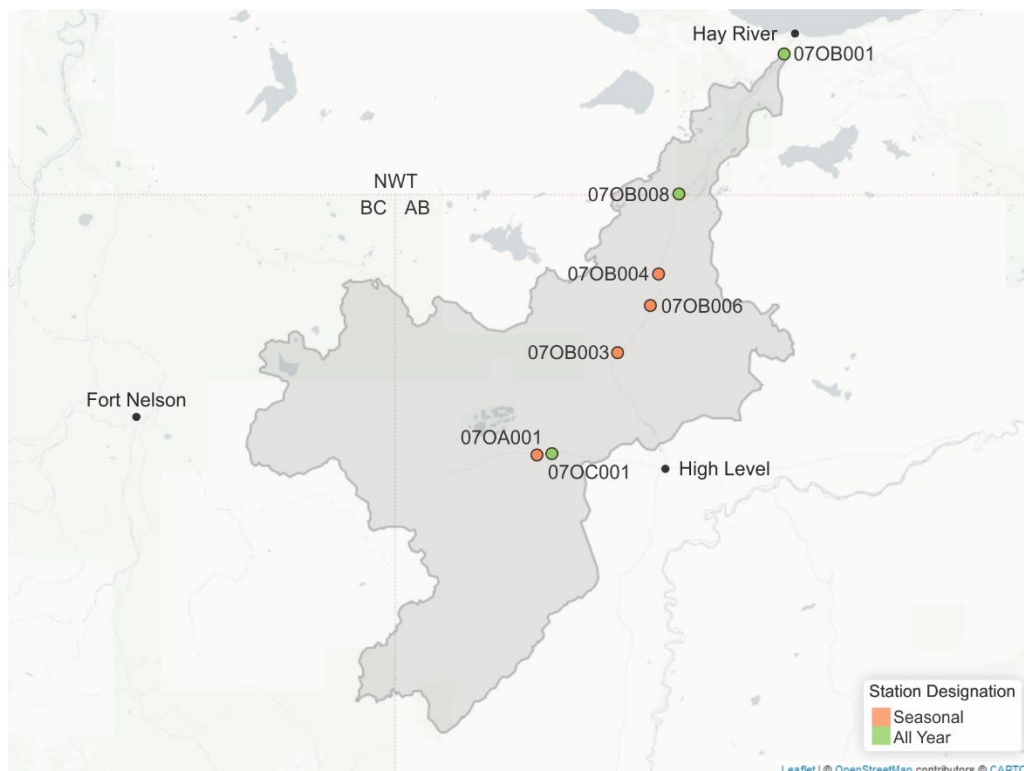
Above – Map of hydrometric stations in the Hay River basin. The station numbers are referenced in the water level plots below.

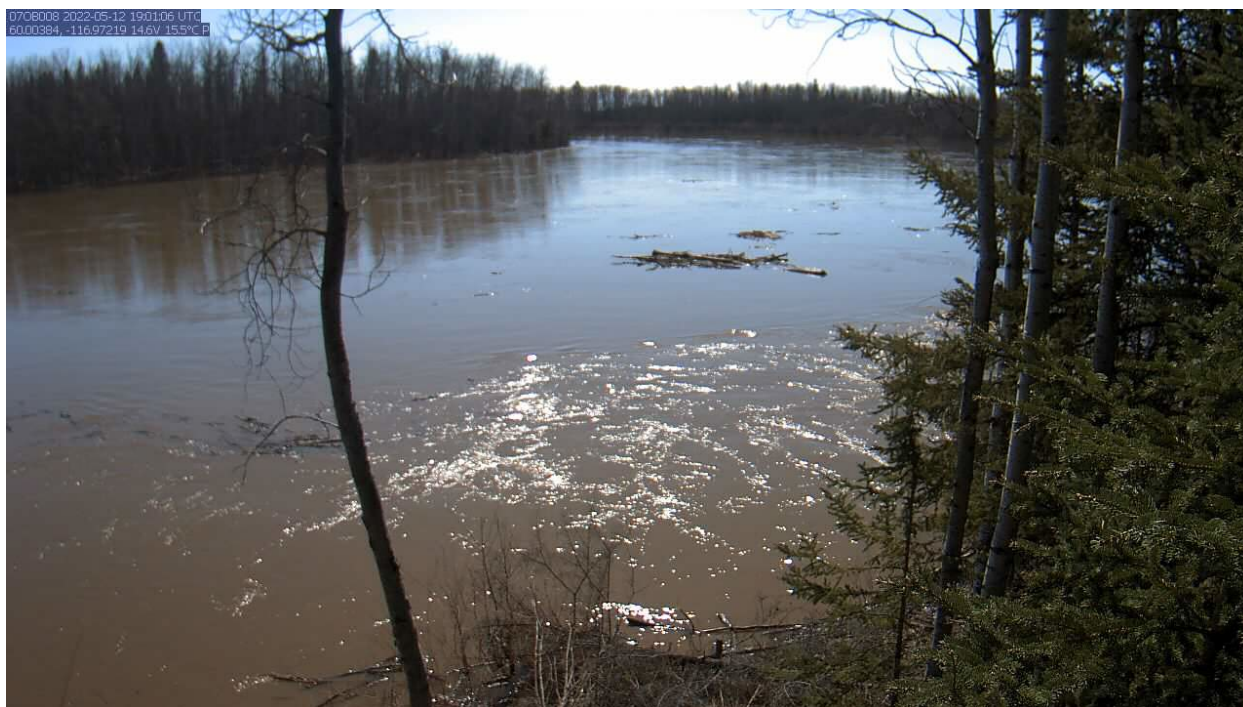
Above – Hay River near the border hydrometric gauge photo on May 12 at 13:00. Photo courtesy of Water Survey of Canada and GNWT.

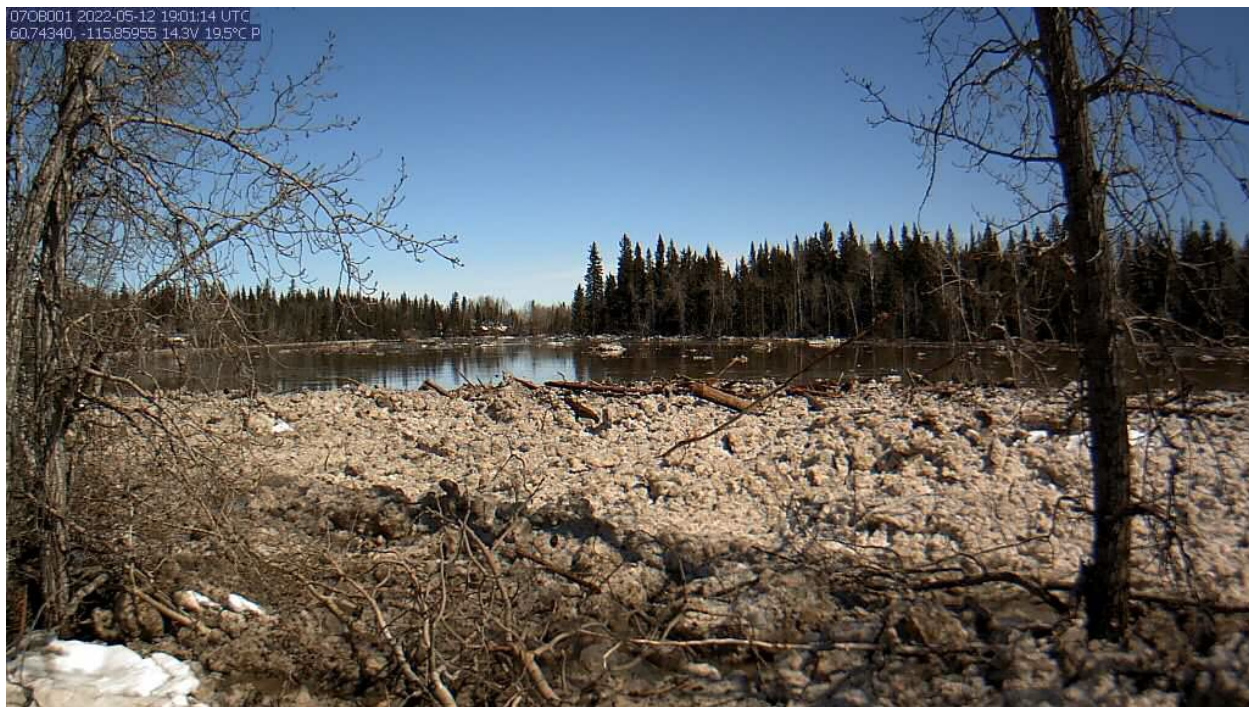
Above – Hay River near the Town of Hay River hydrometric gauge photo on May 12 at 12:00. Photo courtesy of Water Survey of Canada and GNWT.

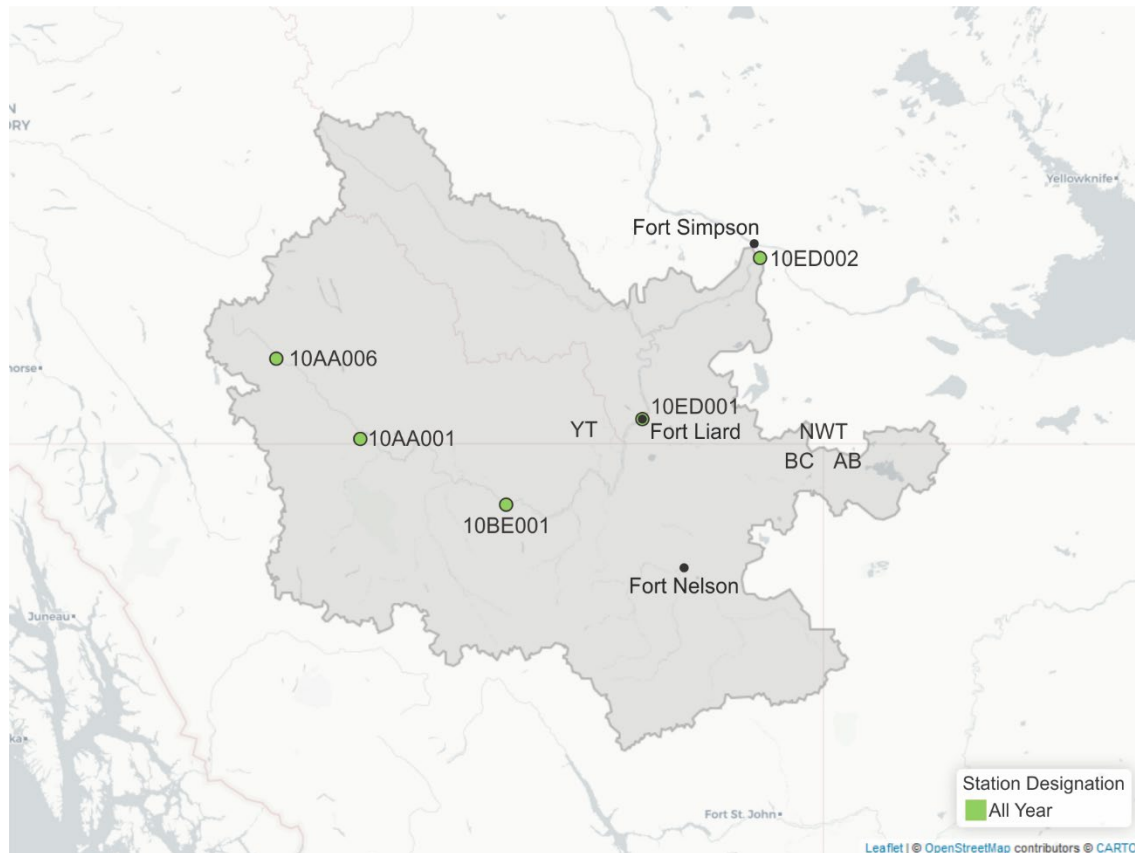
Above – Map of hydrometric stations in the Liard River basin. The station numbers are referenced in the water level plots below.

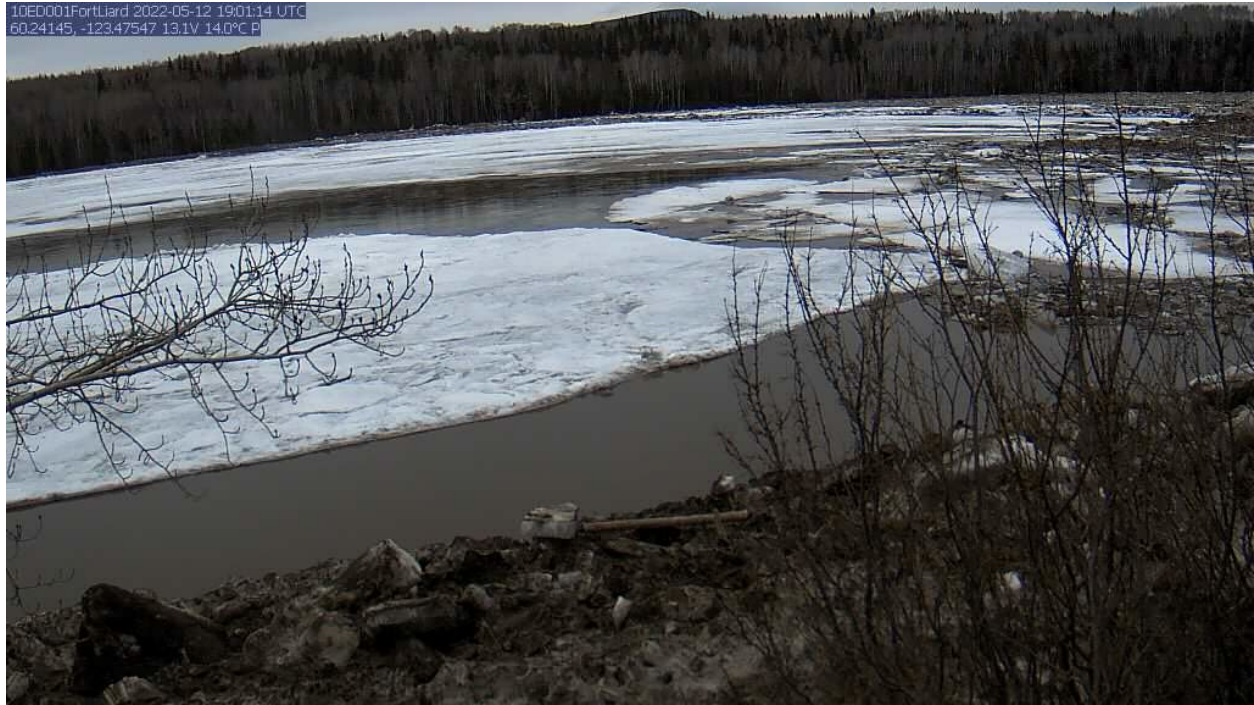
Liard River at Fort Liard [10ED001]:

Above – Liard River at Fort Liard hydrometric gauge photo from May 12 at 13:00. Photo courtesy of Water Survey of Canada and GNWT.

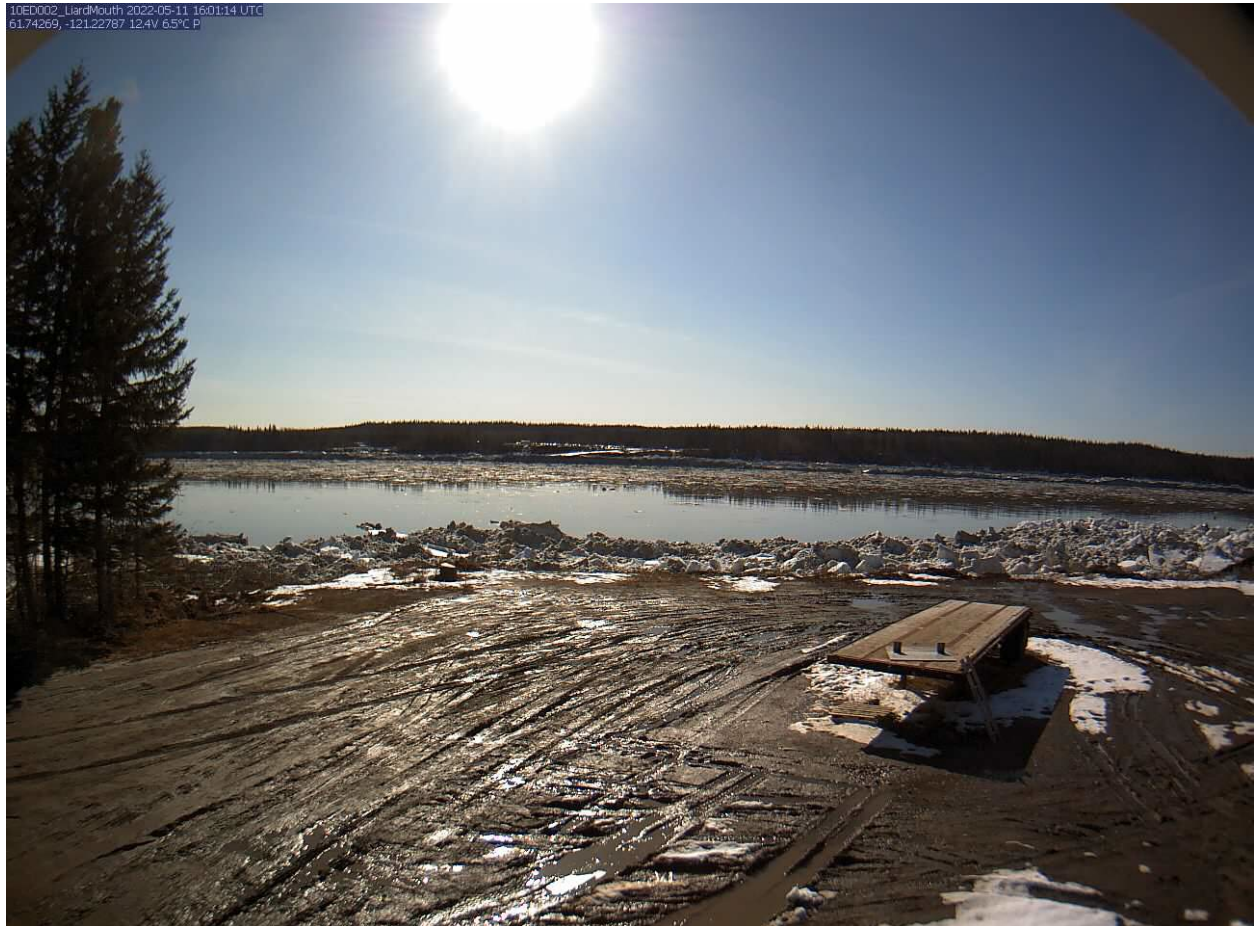
Liard River near the mouth [10ED002]:

Note: The gauge is not currently producing data. Water Survey of Canada of Canada staff visited the gauge on May 07 at 10:20 and measured an instantaneous water level of 4.55 m and on May 09 at 10:15 and measured an instantaneous water level of 9.16 m.

Above – Liard River near the mouth hydrometric gauge photo from May 11 at 10:00. Photo courtesy of Water Survey of Canada and GNWT.

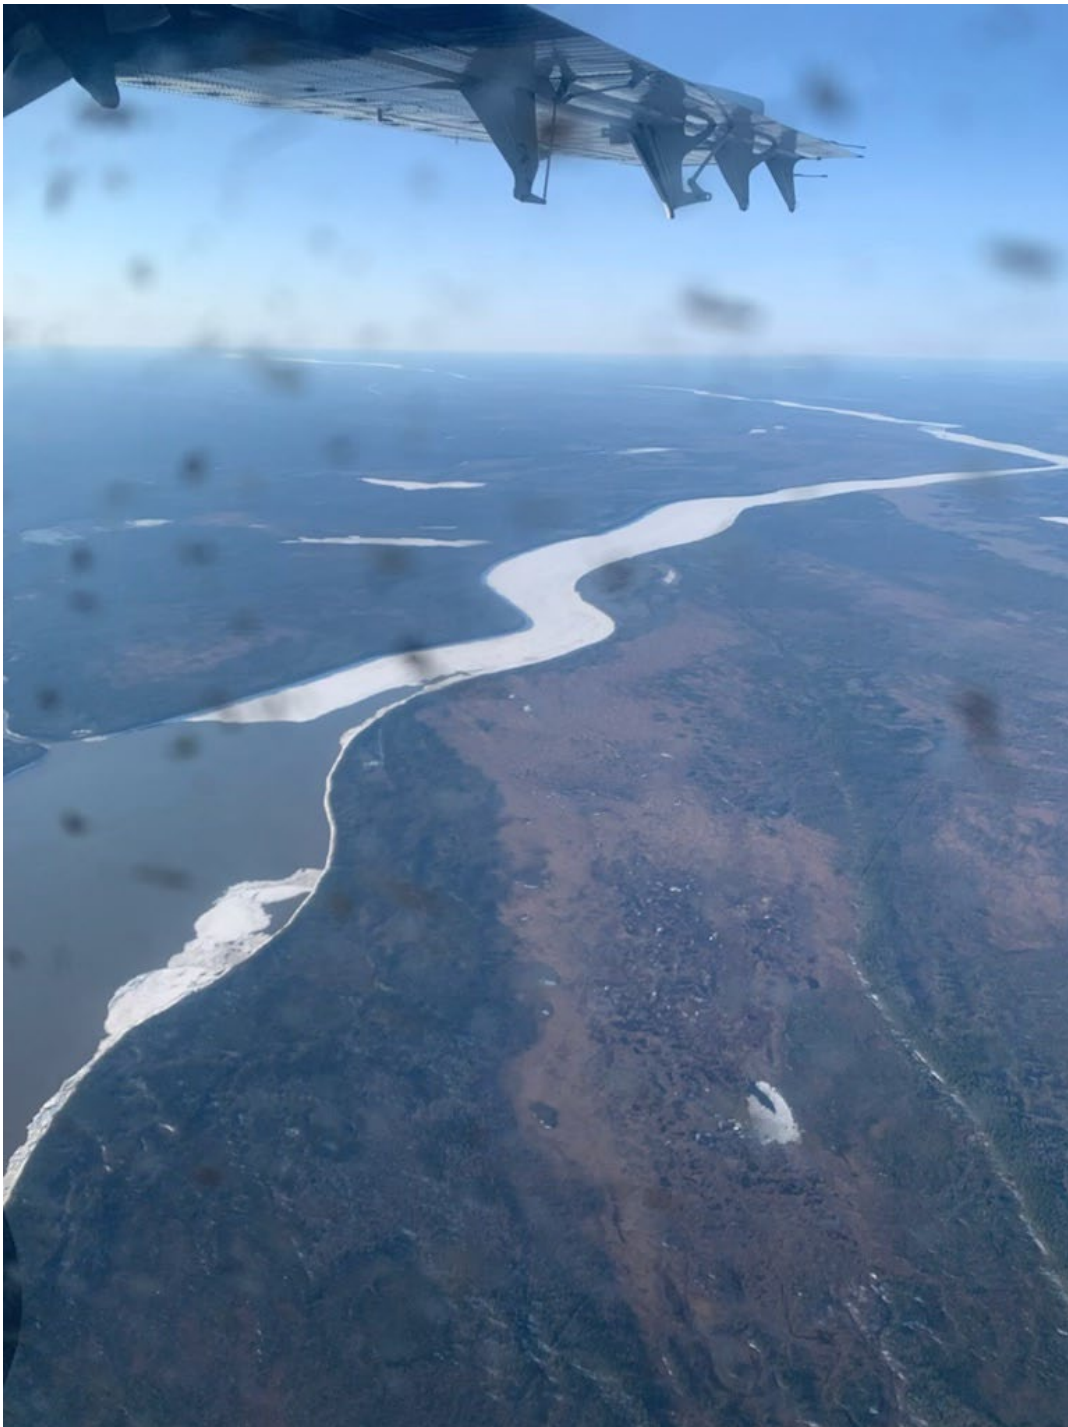
Above – The Mackenzie River at the Rabbitskin River (lefthand side of photo, where the ice cover stops) from 09:00 on May 12. The top of the image is upstream towards Jean Marie River. There is open water on the Mackenzie River downstream of this photo through Fort Simpson. *Photo courtesy of GNWT.*

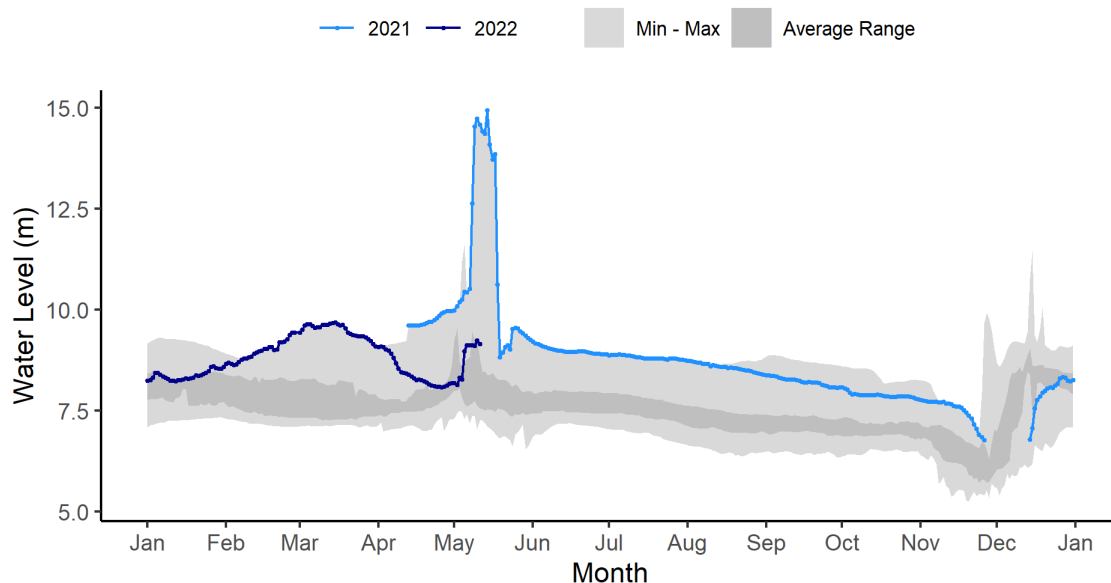
Mackenzie River at Strong Point [10FB006]:

Above – hydrograph of daily average levels for the previous two years. Note that the most recent point on this graph shows the **daily average level from May 10** (yesterday).

Above - The upper graph in the figure presents real time water level data at 5-minute resolution with the dashed line representing the peak water level from last year (2021). The lower graph shows daily average levels relative to the previous 20 years.

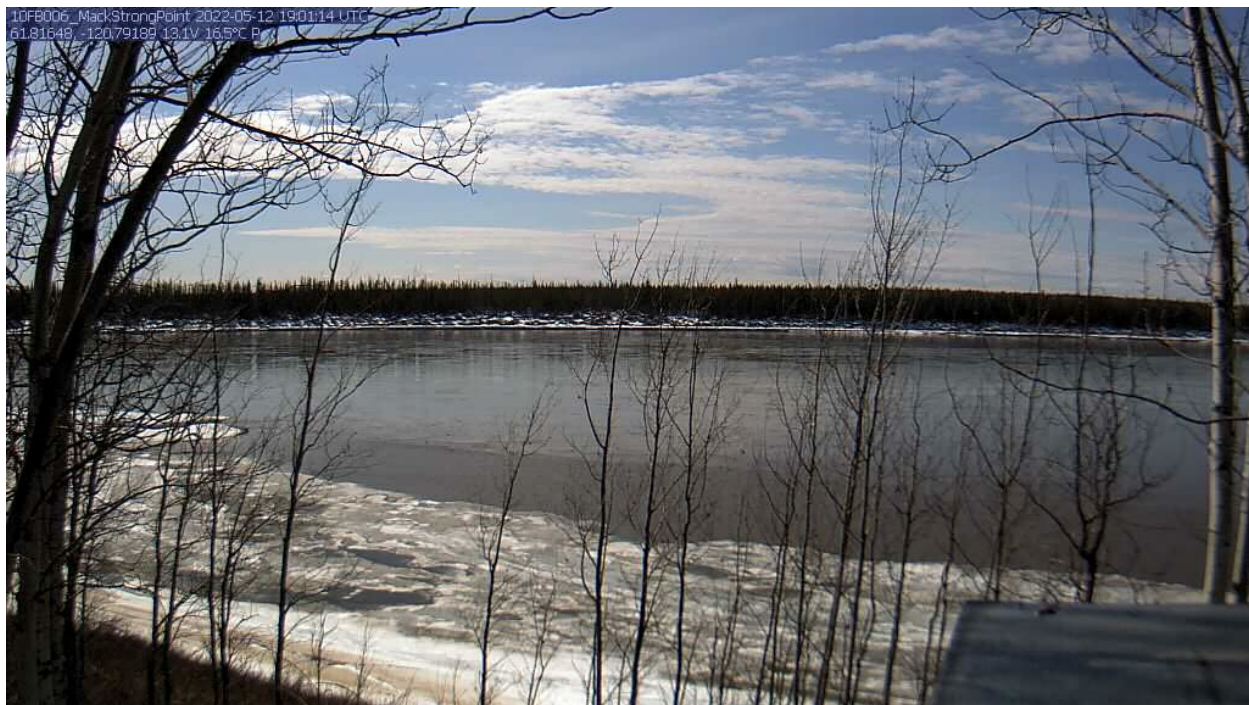
Above – Dehcho (Mackenzie River) at Strong Point hydrometric gauge photo from May 12 at 13:00. Photo courtesy of Water Survey of Canada and GNWT.

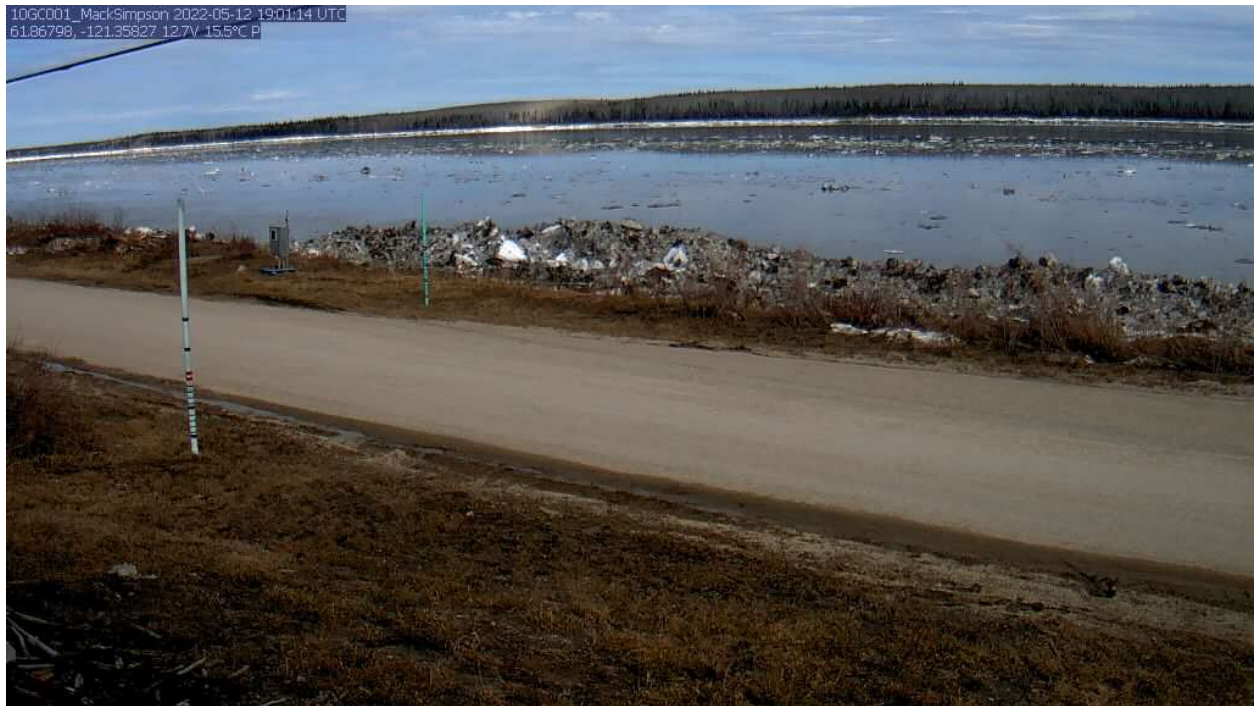
Mackenzie River at Fort Simpson [10GC001]:

Note: The sensor is not currently producing data. The river is open at Fort Simpson and small amounts of ice are moving well.

Above – Dehcho (Mackenzie River) at Fort Simpson hydrometric gauge photo from May 12 at 13:00. Photo courtesy of Water Survey of Canada and GNWT.

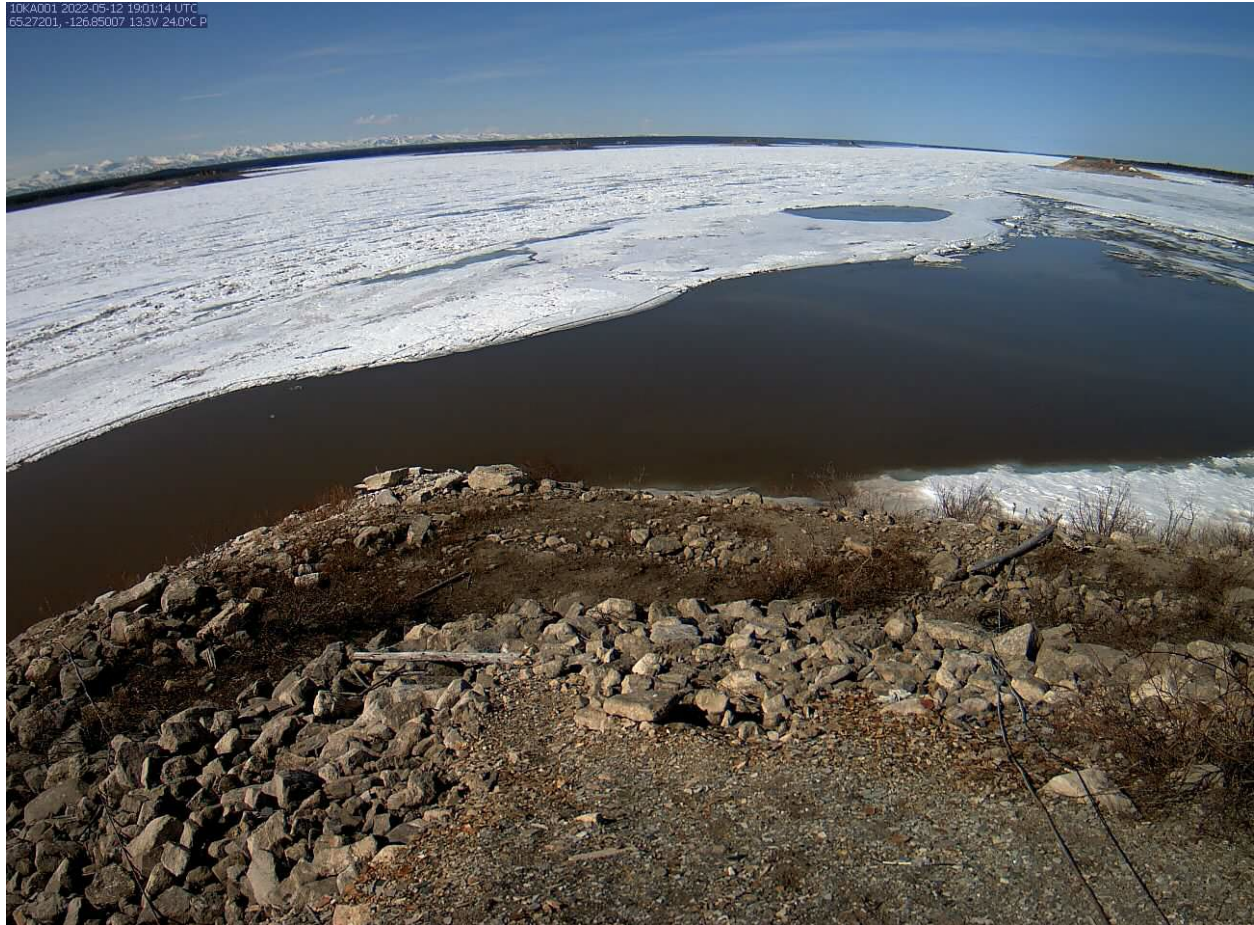
Above – Mackenzie River at Norman Wells hydrometric gauge photo from May 12 at 13:00. Photo courtesy of Water Survey of Canada and GNWT.

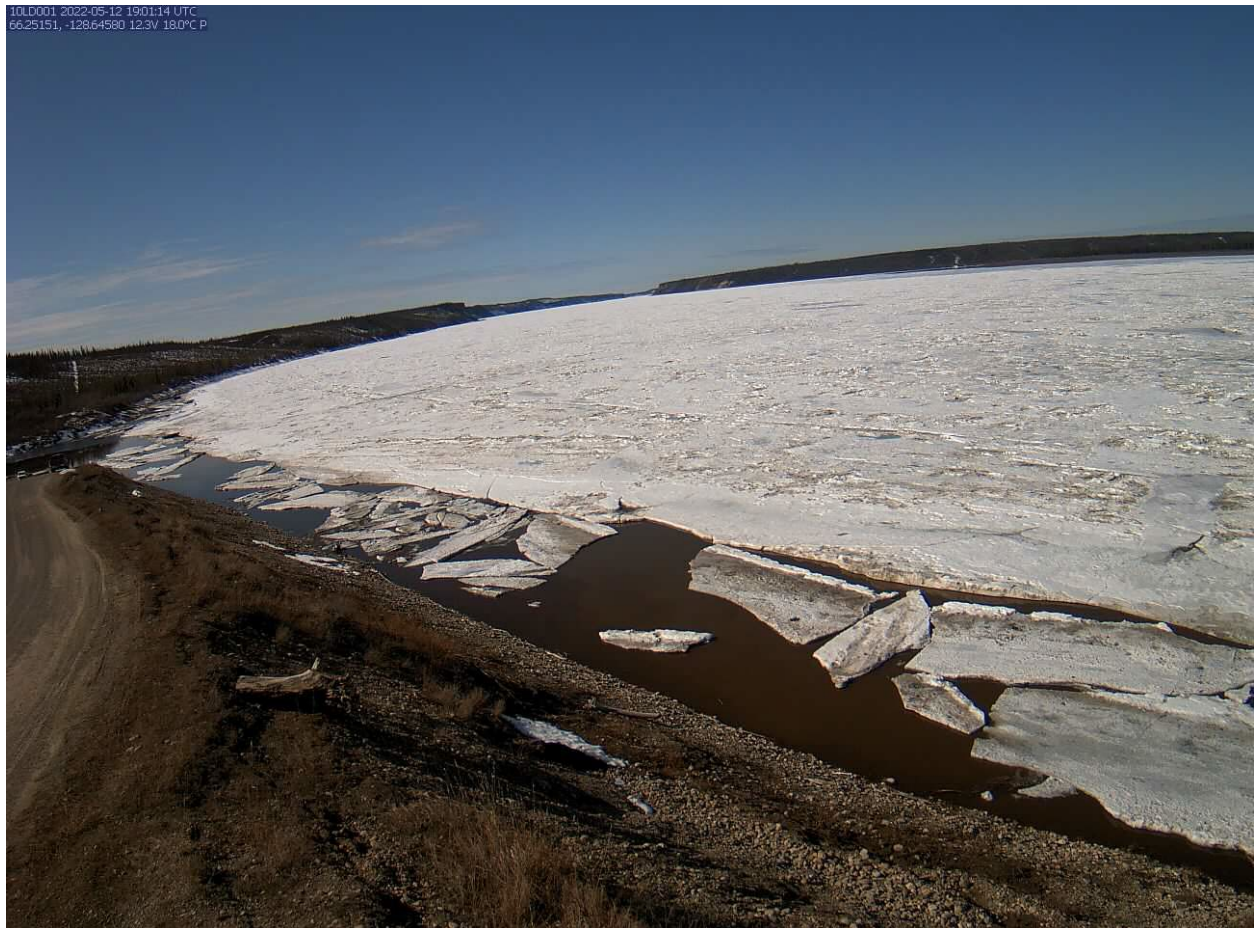
Mackenzie River at Fort Good Hope [10LD001]:

Above – Mackenzie River at Fort Good Hope hydrometric gauge photo from May 12 at 13:00. Photo courtesy of Water Survey of Canada and GNWT.

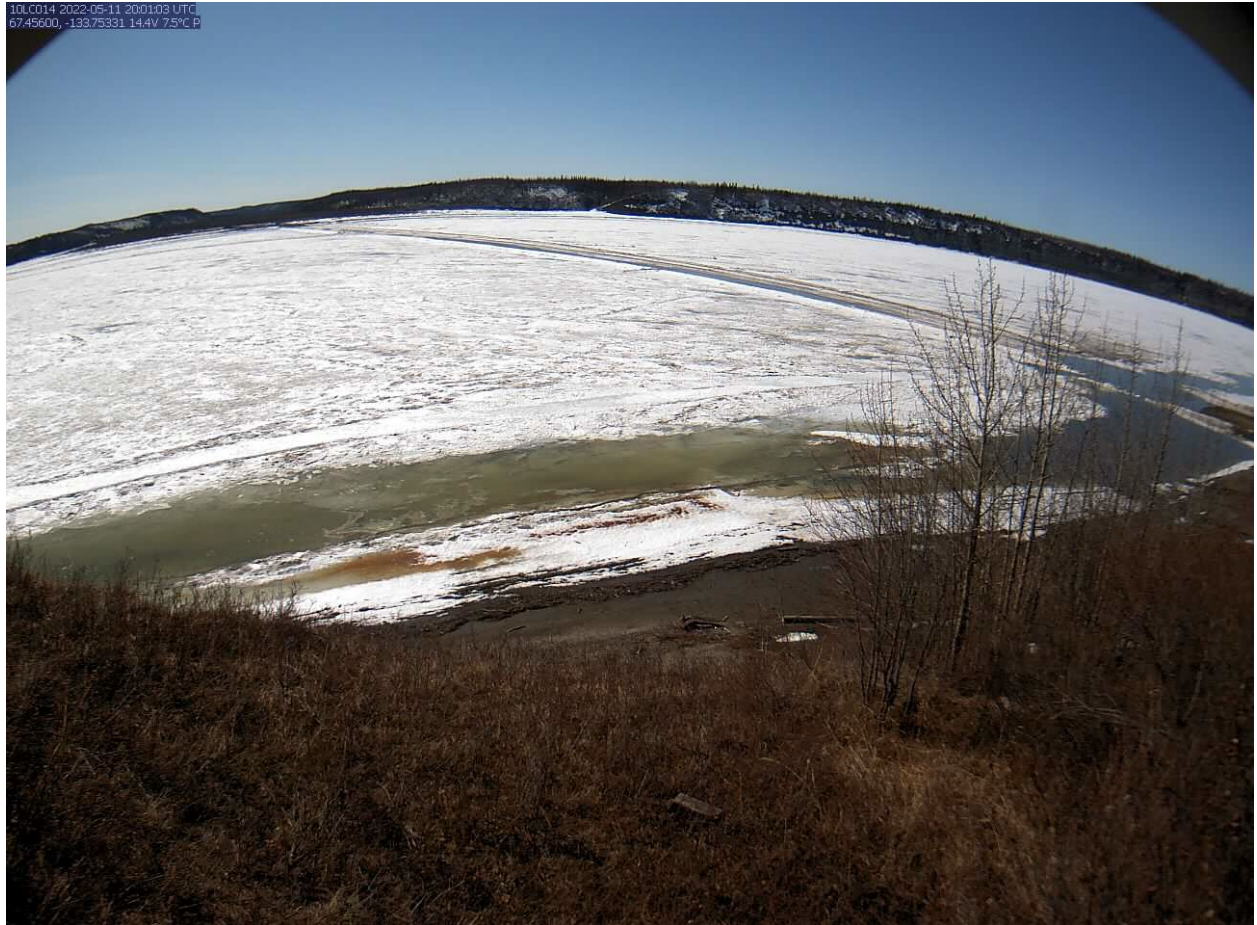
Above – Mackenzie River at Arctic Red River hydrometric gauge photo from May 11 at 13:00. Photo courtesy of Water Survey of Canada and GNWT.

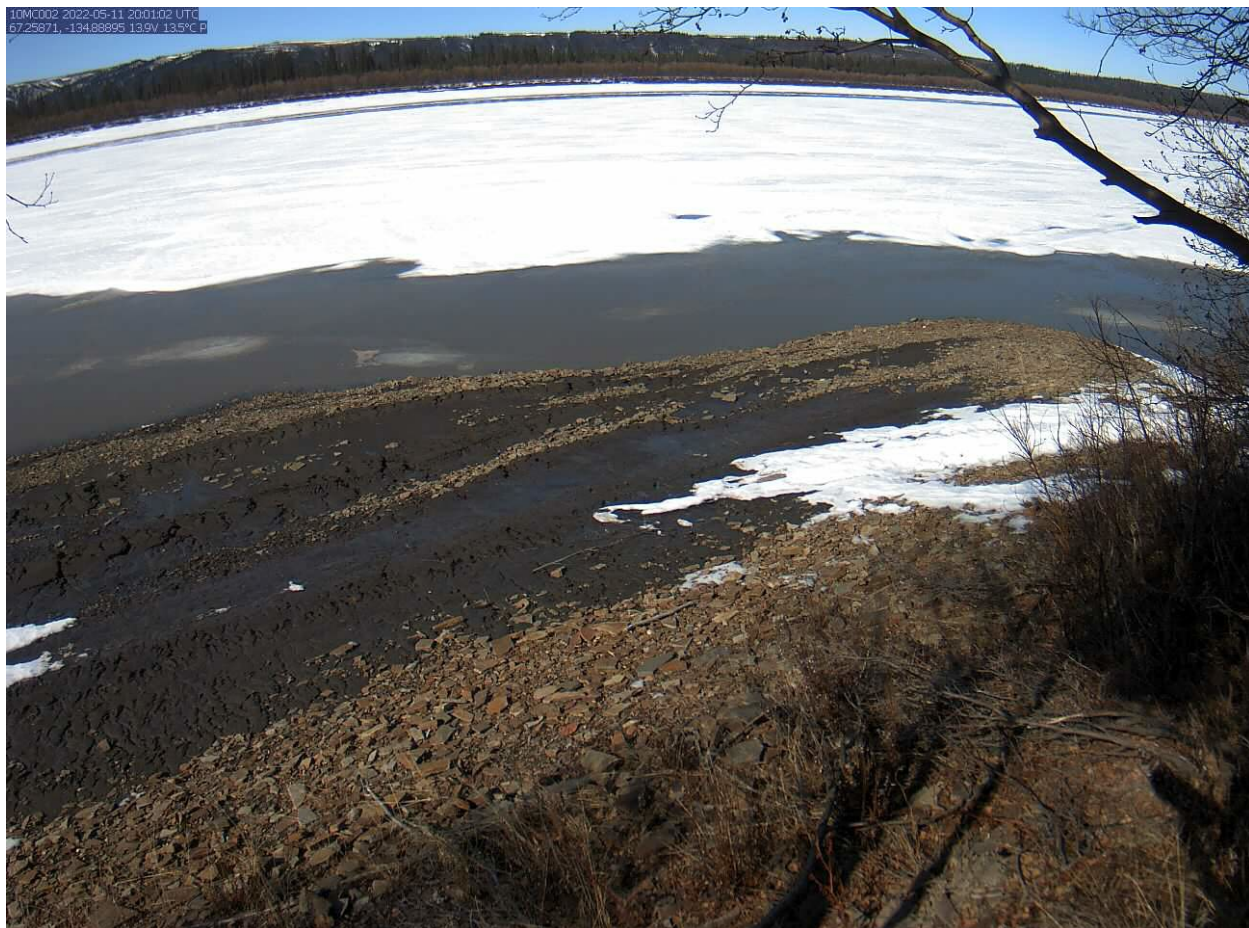
Above – Peel River at Fort McPherson hydrometric gauge photo from May 11 at 14:00. Photo courtesy of Water Survey of Canada and GNWT.
